The Repowered and Extended Ben Aketil Wind Farm: Peat Slide Risk Assessment

Technical Appendix 9.1

663617-P9.1 (00)

MAY 2023

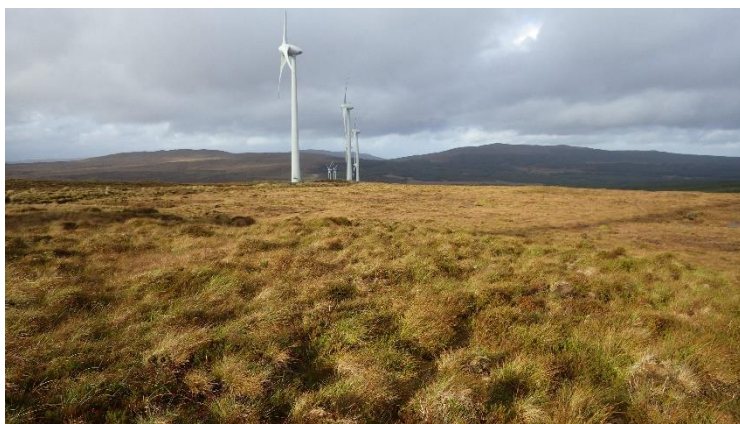
A) View along existing wind farm looking NW, NGR NG 3243 4708

Photograph shows a typical view of the northern part of the Site looking along the line of the current Ben Aketil Wind Farm. Vegetation is a mix of heather, sedges, grasses and *Sphagnum* moss.

Peat depths in this area vary from <0.5 to >3.0 m. Most peat is less than 1.5 m, although deeper peat around 2.0-2.5 m is present in the flat area immediately right of the turbines.

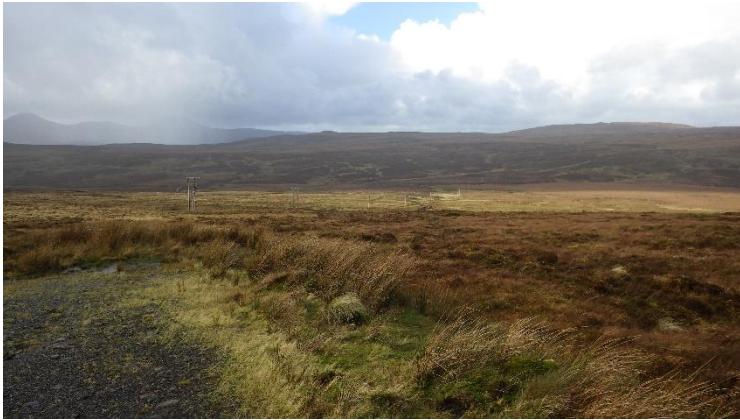
<p>B) View SW across the Developable Area, NGR NG 3167 4811</p> <p>Photograph shows a view across the Caroy River valley from the existing wind farm substation. The existing export power line is visible across the photograph. Vegetation here is dominated by heather in the mid-ground, becoming more grassy and sedge-rich on the lower slopes. Pale areas in the distance identify drainage channels.</p> <p>Peat in this area is very variable. The foreground has no peat, although peat up to 4.3 m has been recorded on the flatter ground in the middle distance.</p>

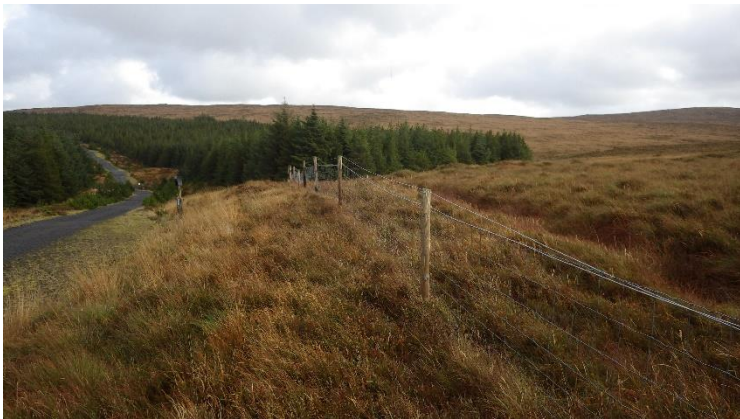
<p>C) View along Northern Site Access from the Site entry, NGR NG 3175 4819</p> <p>Photograph shows the existing access track leading away from the Site, and the area of commercial forestry plantation.</p> <p>Peat in this area is mostly shallow (<1.0 m) although a pocket of peat up to 2.2 m has been identified in the mid-ground area, before the forestry margin.</p>

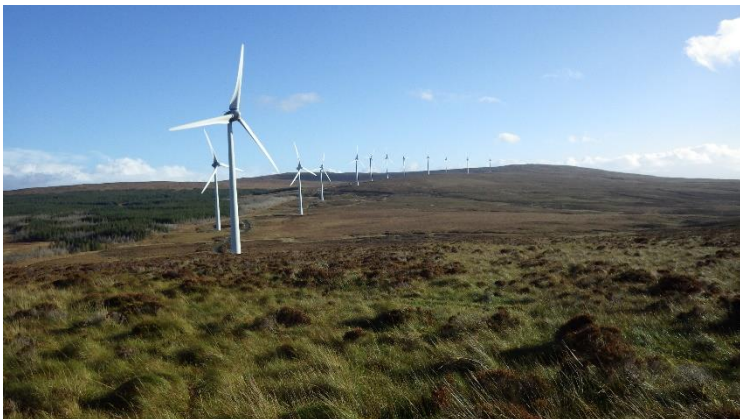
<p>D) View SE along the existing wind farm to Ben Aketil, NGR NG 3052 4881</p> <p>Photograph across the headwaters area of the Caroy River, showing the forestry plantation to the north and the northern part of the Developable Area.</p> <p>Peat in this area is deep, notably in the flatter ground around the Caroy River headwaters, with records up to 5.4 m.</p>

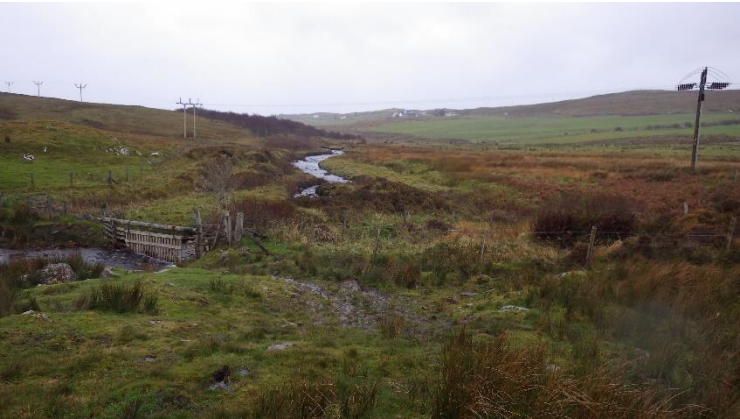
<p>H) View S along the Aketil Burn to the Caroy River and the coast, NGR NG 3029 4493</p> <p>Photograph across the confluence of the Aketil Burn and Caroy River, showing the rough grazing and improved pasture in this area.</p> <p>This part of the Site is largely without peat. Some small pockets of peat <1.0 m have been identified but are typically small and isolated.</p>

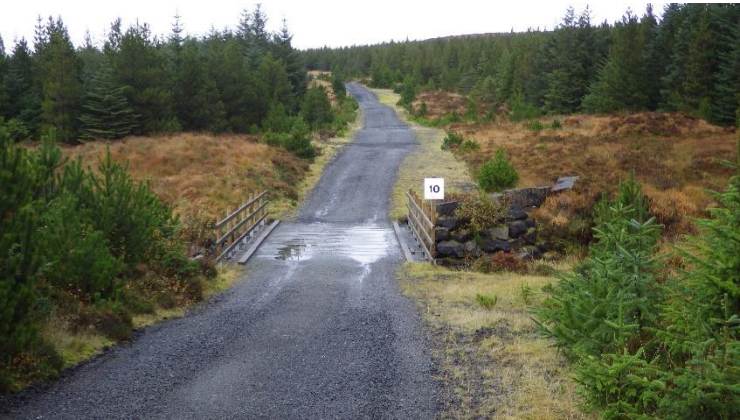
<p>I) View NE along the existing Northern Site Access, NGR NG 3189 4826</p> <p>Photograph along the existing access track into the Site, showing the forestry plantation and track margins. A crossing of the Allt a Choire is visible in the foreground.</p> <p>Peat in this area variable, mainly <1.0 m but with some records up to 2.0 m. It is possible that the deeper areas reflect peat relocated to permit construction of the access track.</p>

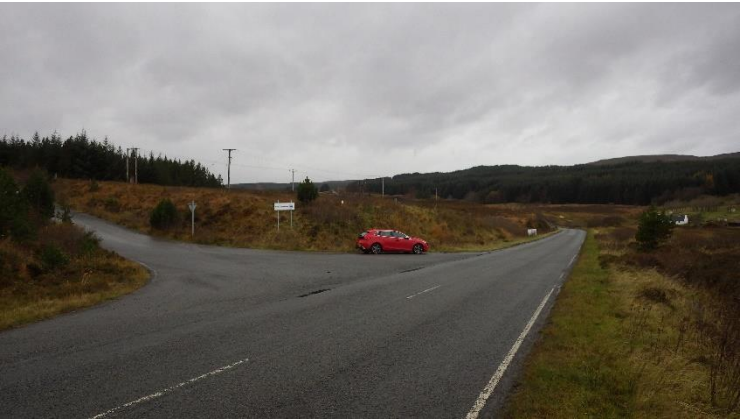
<p>J) View W along the A850 showing the existing track entrance splay, NGR NG 3241 5116</p> <p>Photograph showing the entry to the Ben Aketil Wind Farm track from the A850. The forestry plantation is visible at the left side of the photograph.</p> <p>Peat in this area is mainly <1.0 m with occasional deeper pockets up to 1.8 m. Some of the deeper peat records may reflect relocated as part of the track construction process.</p>

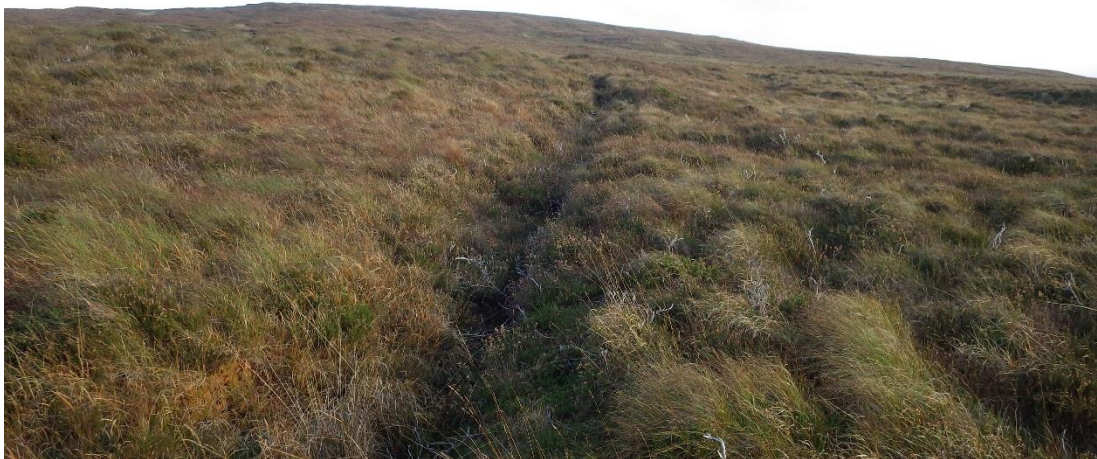
Photograph 9.1.1: Drainage ditch on the lower slopes of Ben Aketil, looking SE from NGR NG 3182 4666.

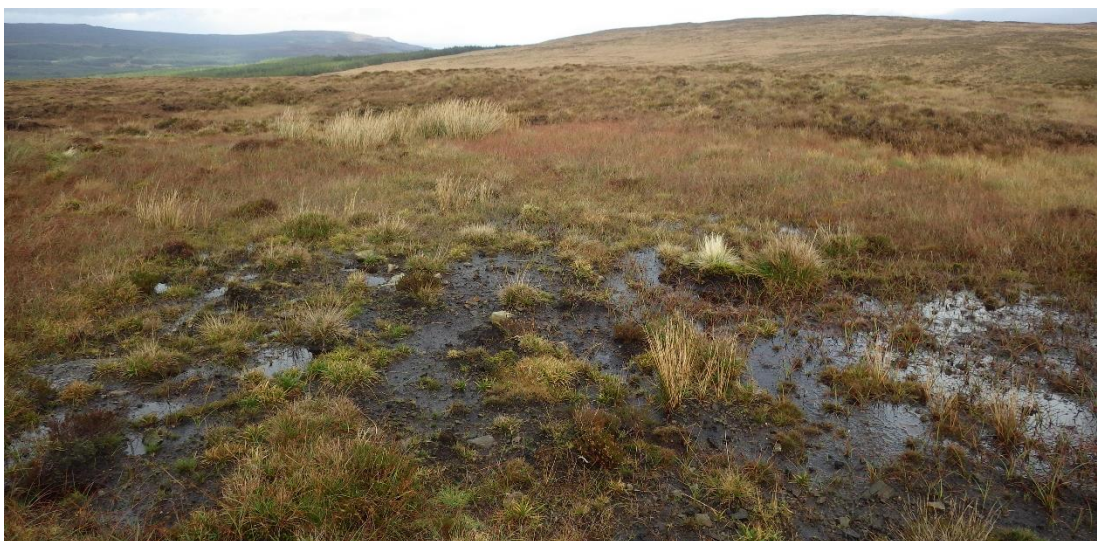
Photograph 9.1.2: Area of bare peat showing signs of active erosion, NGR NG 3222 4752.

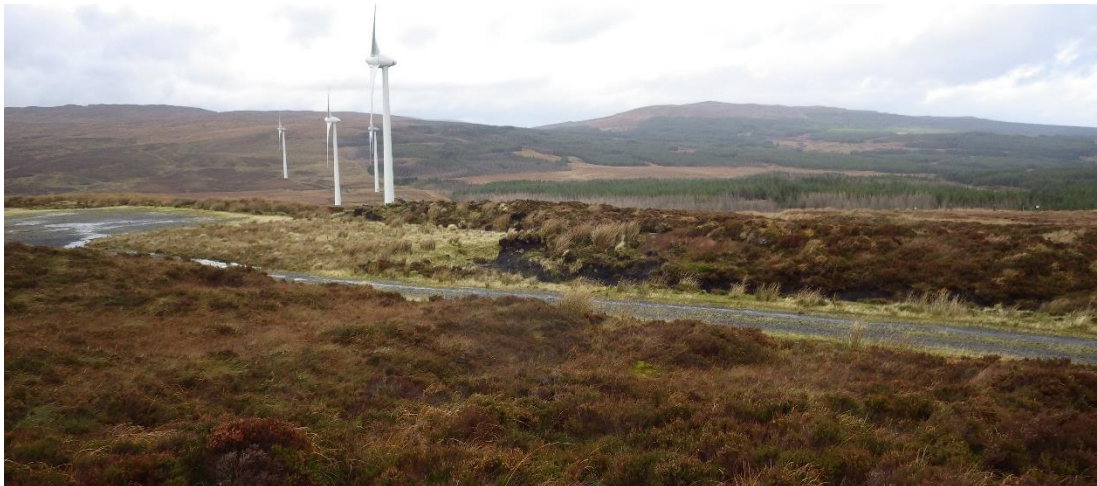
Photograph 9.1.3: Modification and drainage associated with the existing Ben Aketil Wind Farm. View shows access and part of the crane pad for one of the operational turbines. View NW from NGR NG 3168 4815.

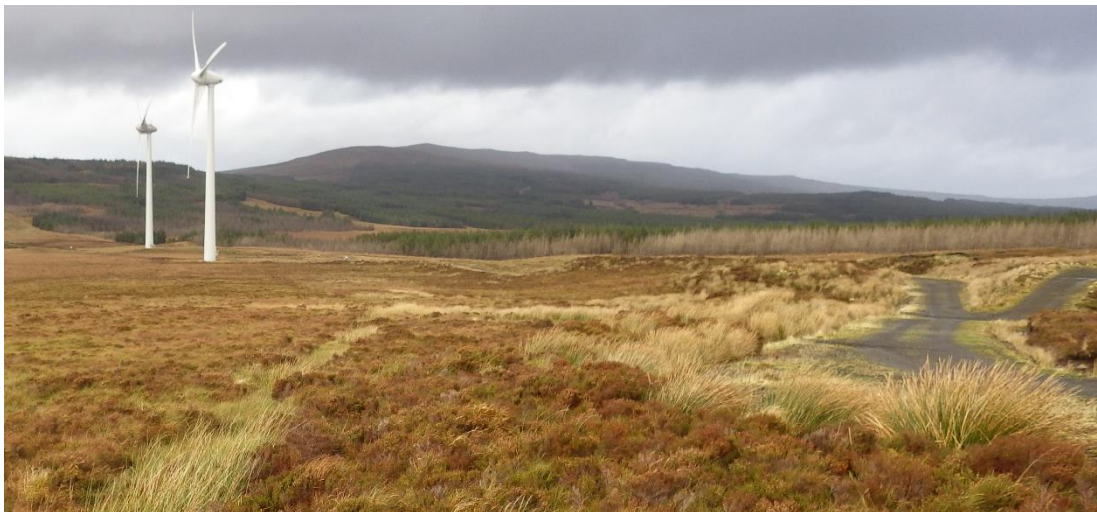
Photograph 9.1.4: Modification and drainage associated with the existing Ben Aketil Wind Farm. View shows access tracks with associated drainage and modified verges. View NW from NGR NG 3142 4819.

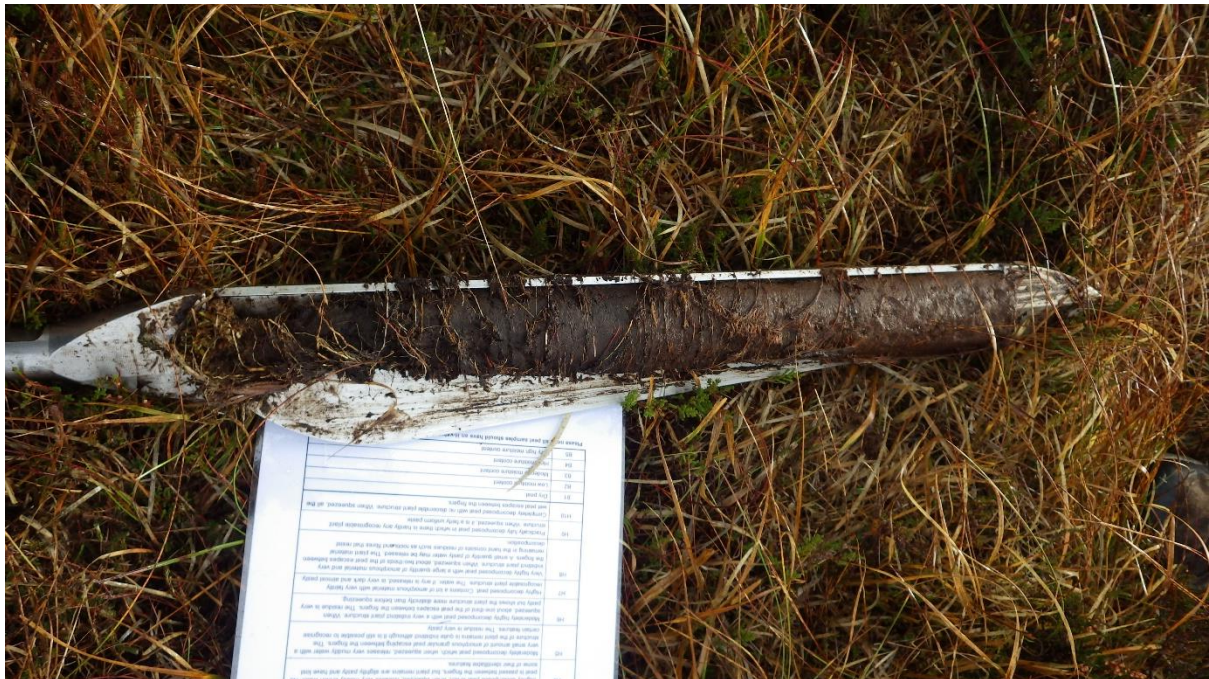
Location: C1	Depth: 0.00 – 0.50 m bgl	Date: 01/11/2022
--------------	--------------------------	------------------

Notes: Core interior of moderately highly decomposed peat with indistinct plant structure and dark brown in colour, overlying slightly to moderately decomposed peat which is lighter in colour and of moderate moisture content.

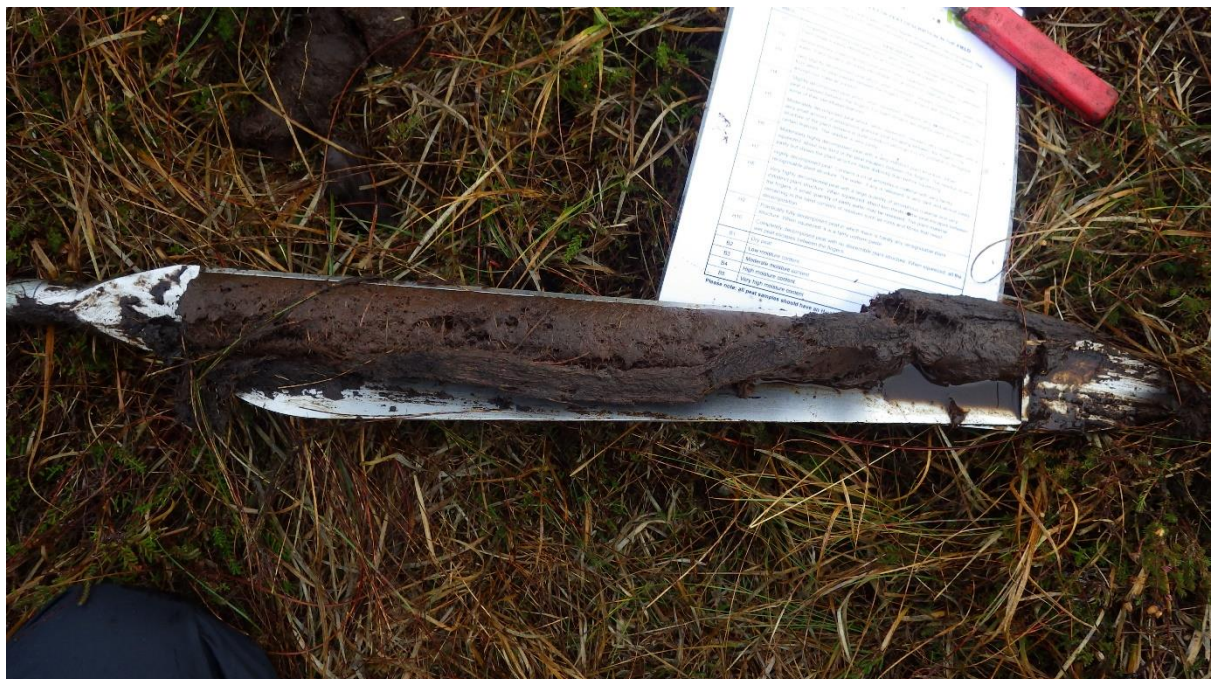
Location: C1	Depth: 0.50 – 1.00 m bgl	Date: 01/11/2022
--------------	--------------------------	------------------

Notes: Core interior of slightly to moderately decomposed peat which is generally amorphous with some root material and high moisture content. Brown to dark brown in colour.

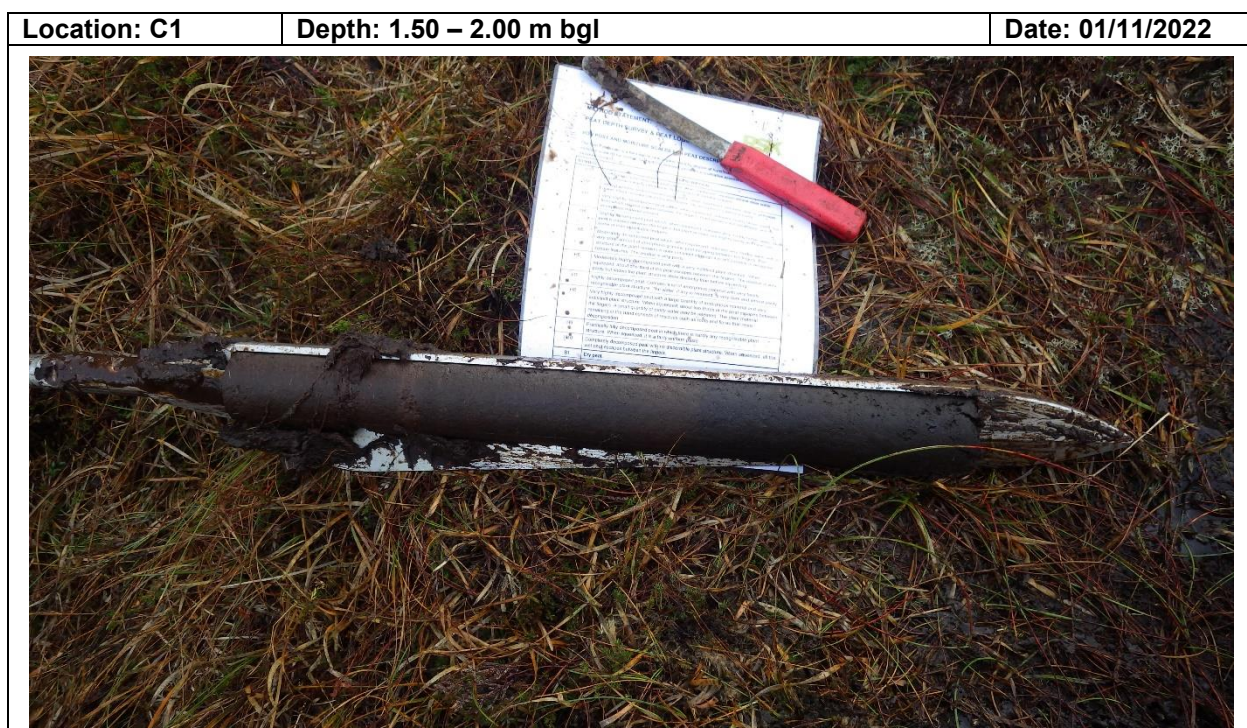
Notes: Core interior of very highly decomposed peat with lots of amorphous material and limited indistinct plant structure. Dark brown in colour with the basal 0.20 m grading into very dark brown.

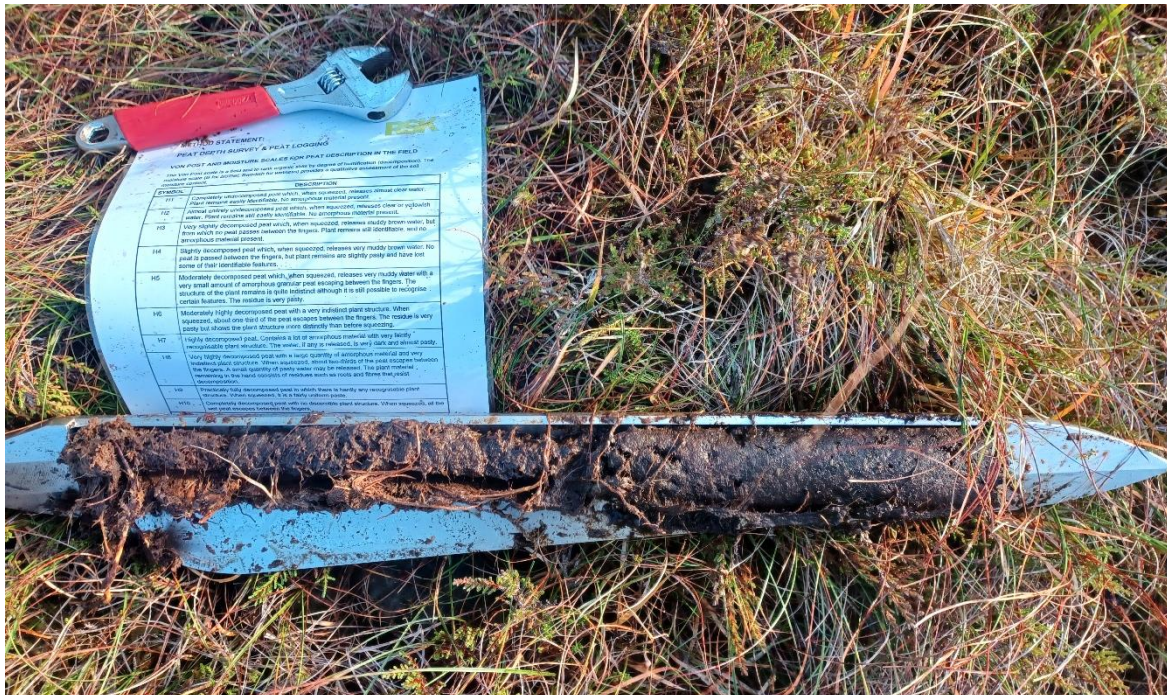
Notes: Core interior of very slightly decomposed peat with identifiable plant remains and no amorphous material, underlain by highly decomposed peat with faintly recognisable plant structure and darker brown in colour than above.

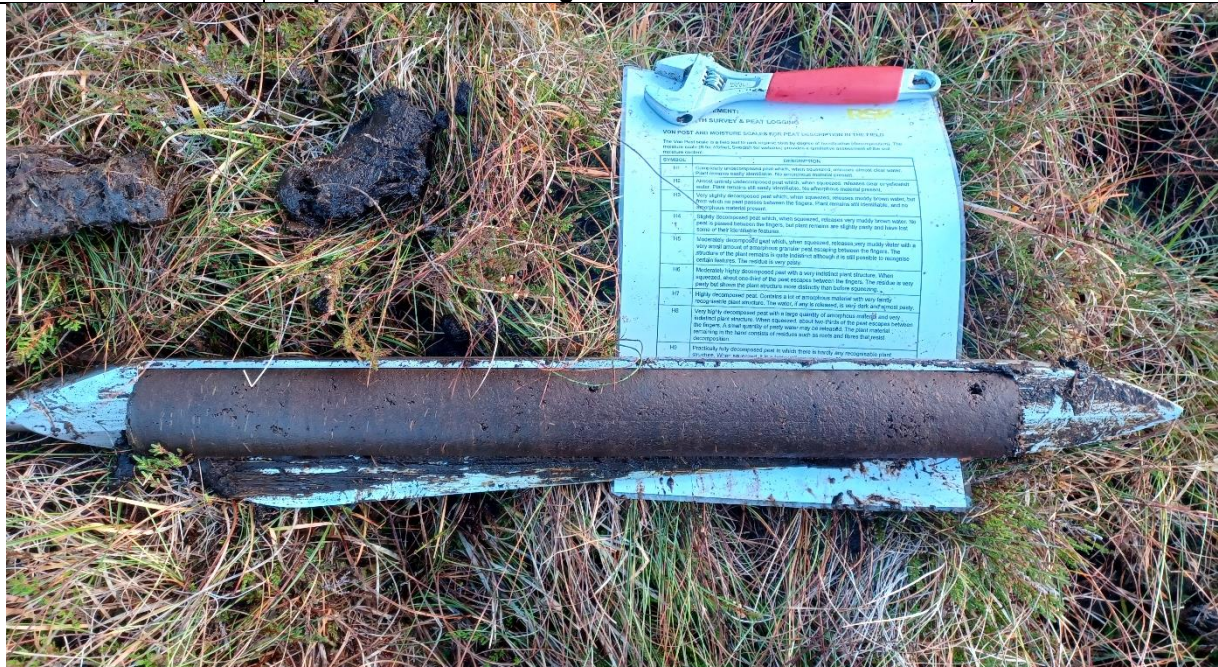
Notes: Core interior of very highly to practically fully decomposed peat with lots of amorphous material and indistinct plant structure. Dark brown with some root fibres present towards the top of the core and more uniform below.

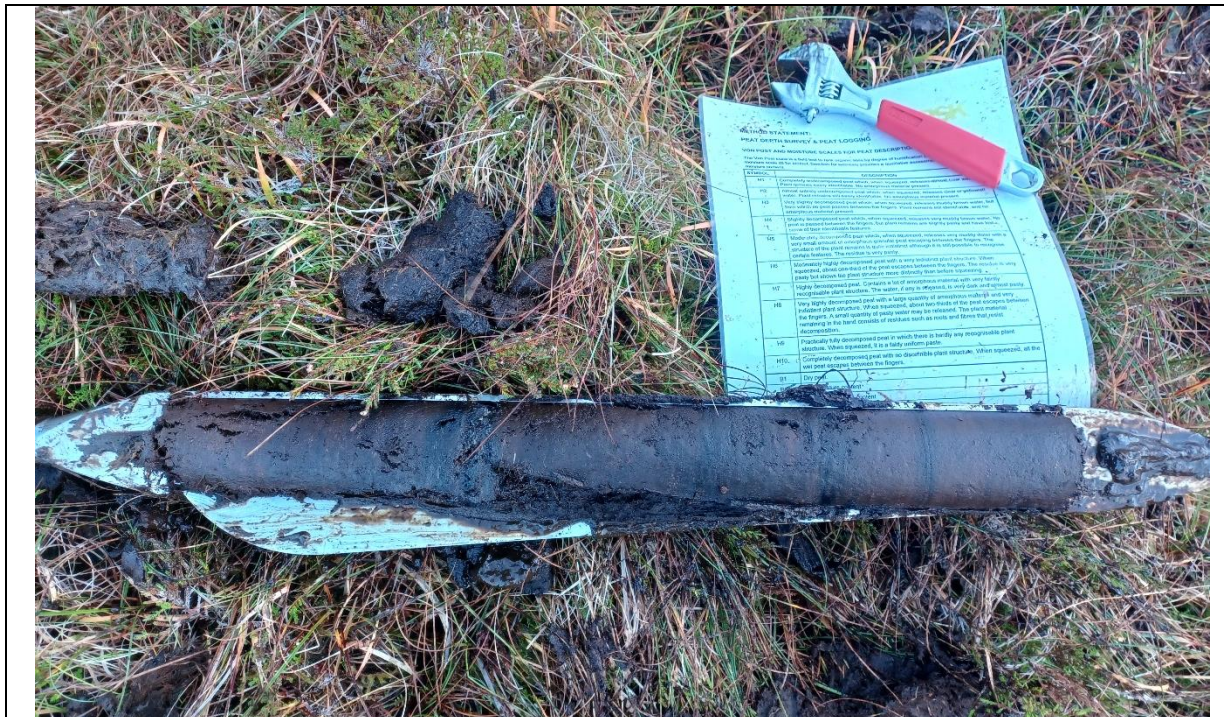
Notes: Core interior of very highly decomposed peat comprising amorphous material and indistinct plant structure. Brown with very dark brown banding throughout.

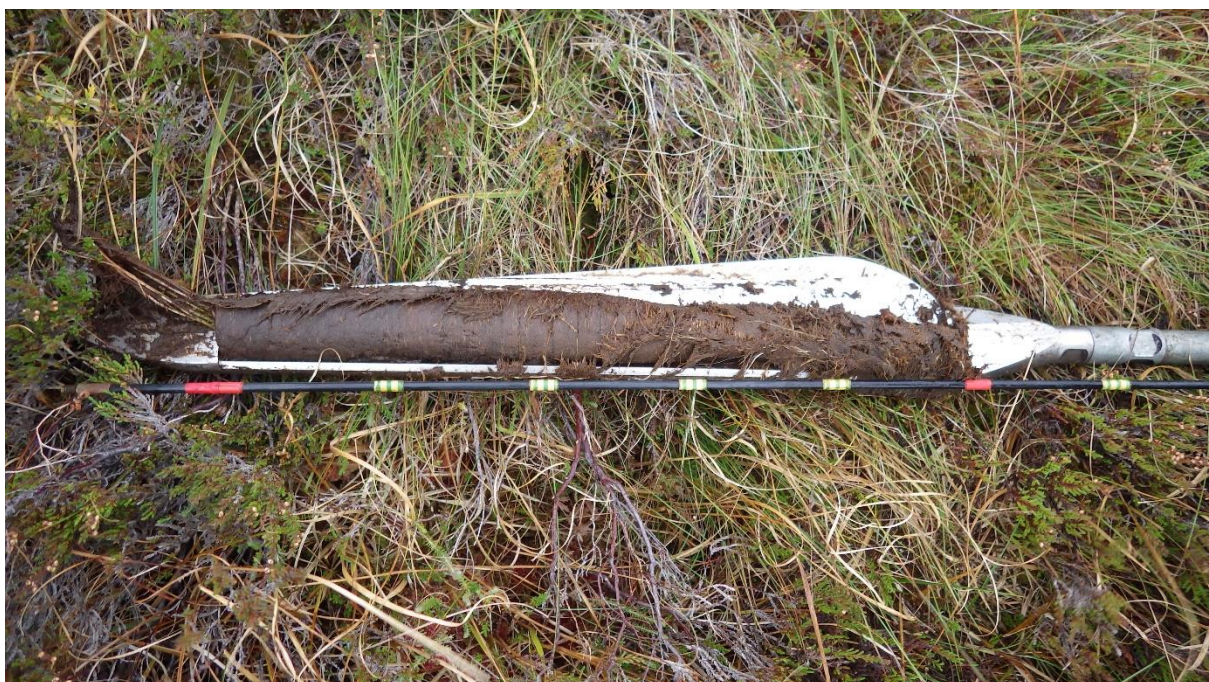
Notes: Core interior of very slightly decomposed peat with identifiable plant remains and light brown in colour, overlying moderately to moderately highly decomposed peat with some fibrous roots which is darker in colour.

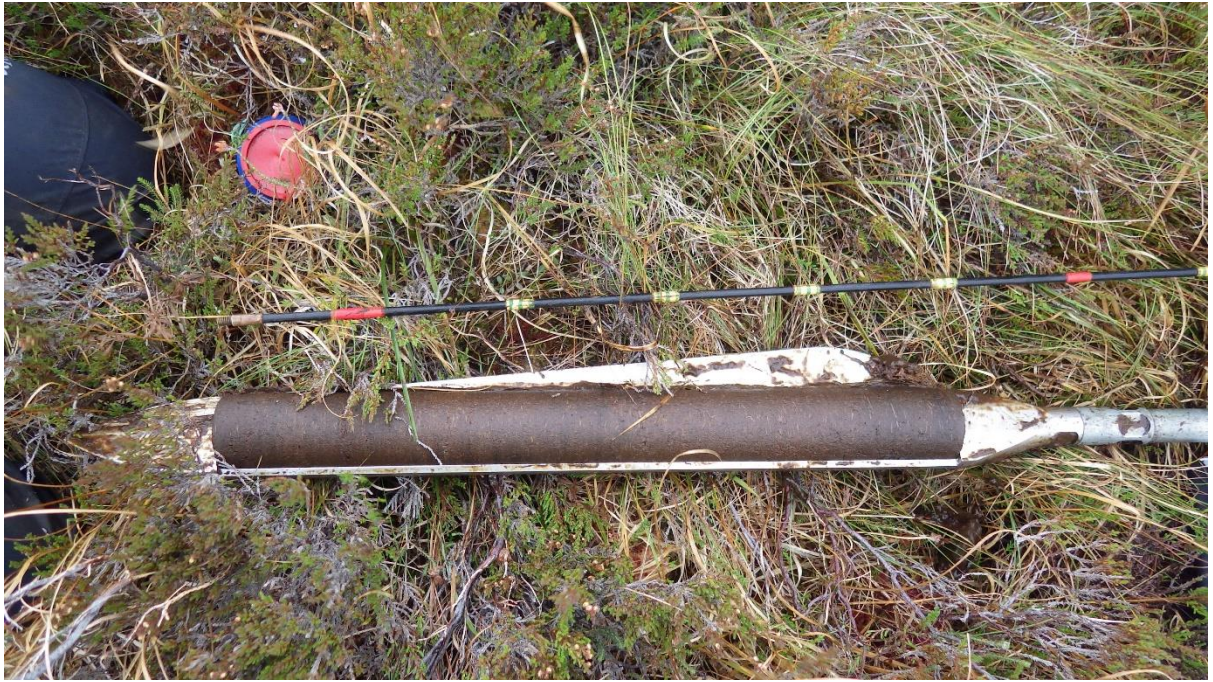
Location: C3	Depth: 0.50 – 1.00 m bgl	Date: 02/11/2022

<p>Notes: Core interior of moderately highly to highly decomposed peat with faintly recognisable plant structure. The top of the core is slightly darker in colour compared to below which is mid-brown.</p>

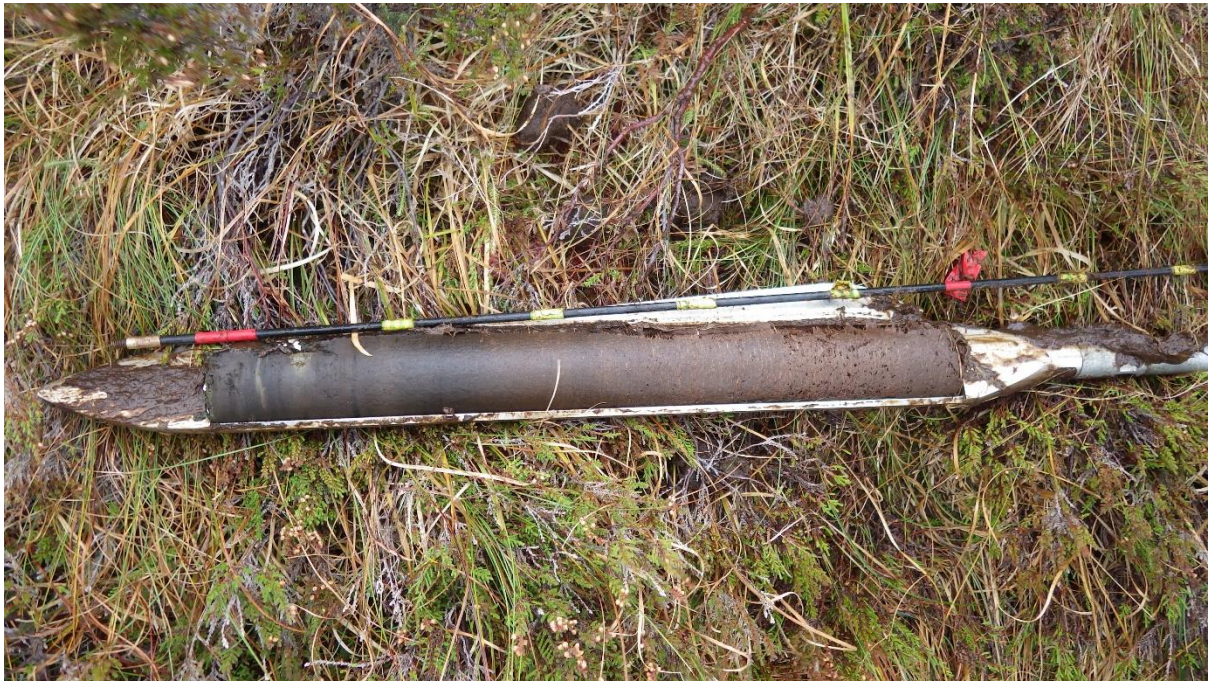
Location: C3	Depth: 1.00 – 1.50 m bgl	Date: 02/11/2022

<p>Notes: Core interior of moderately highly decomposed peat which at the top is slightly fibrous. This overlies very highly decomposed peat which has bands of grey silty mineral soil and grit.</p>
